COMBINED FIRE AND HEALTH & SAFETY RISK ASSESSMENT.

Address of premises:	1-4 Buthay Court Royal Wootton Bassett SN4 7FR
Responsible Person:	The Ropeyard (Wootton Bassett) Management Company Limited
Duty Holder:	Block Management Limited
Person(s) consulted:	No occupier or other relevant person available to consult.
Assessor:	Rob Cockburn
Report validated by:	John Godfrey, GIFireE.
Date of fire risk assessment:	4 th November 2025
Date of previous fire risk assessment:	September 2023
Suggested date for review:	November 2026

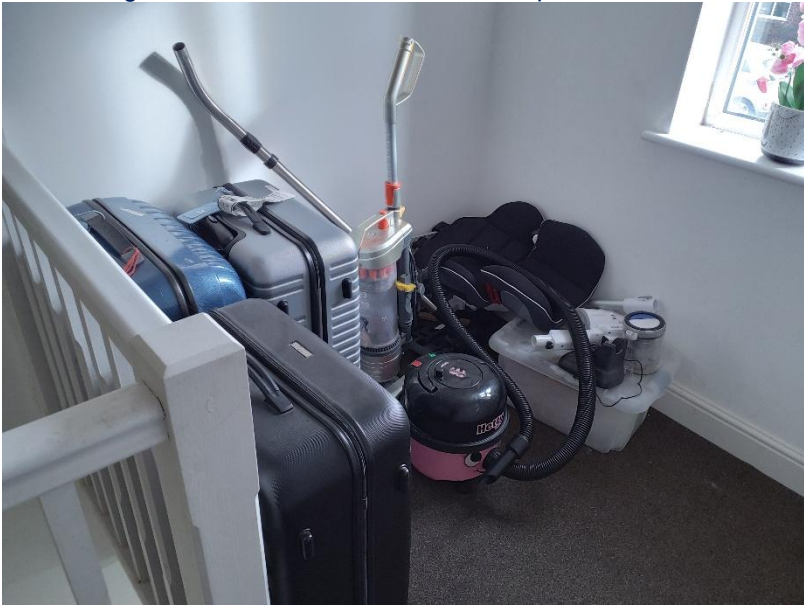
Item	Recommendation	Priority	Timescale
01	<p>Housekeeping was found to be of a poor standard at the time of this assessment with the communal areas and escape routes congested with residents' possessions and storage. It is recommended that the client arrange for the communal areas to be cleared as a priority and all residents reminded of the importance of maintaining sterile communal areas and escape routes.</p>

2	B

Ongoing action required

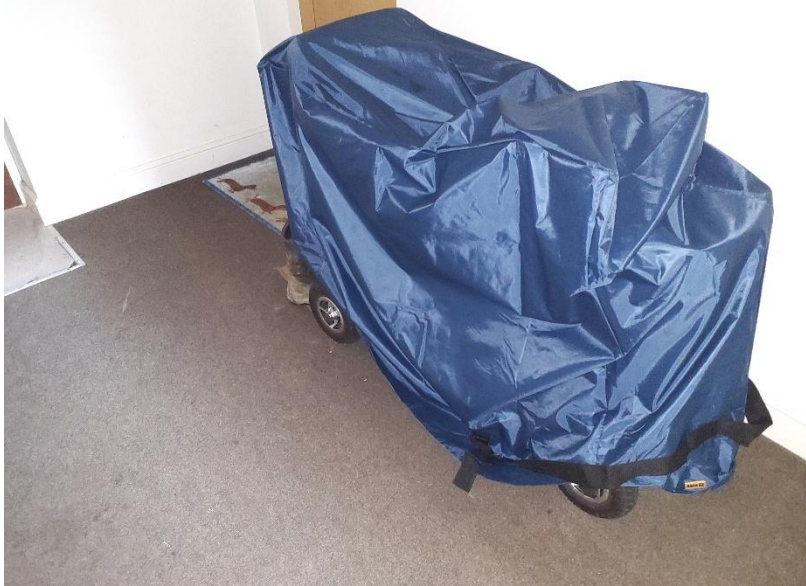
02	<p>It was noted during this fire risk assessment that there was a mobility scooter located within the ground floor communal area which poses a significant fire hazard. It is recommended that this is moved out of the communal area and that residents are reminded that the communal area must remain sterile at all time and free from any potential ignition sources to protect the means of escape.</p>

1	B	Ongoing action required As above
----	---------------------------------------------------------------------------------------------------------------------------------------------------------------------------------------------------------------------------------------------------------------------------------------------------------------------------------------------------------------------------------------------------------------------------------------------------------------------------------------------------	---	---	-------------------------------------

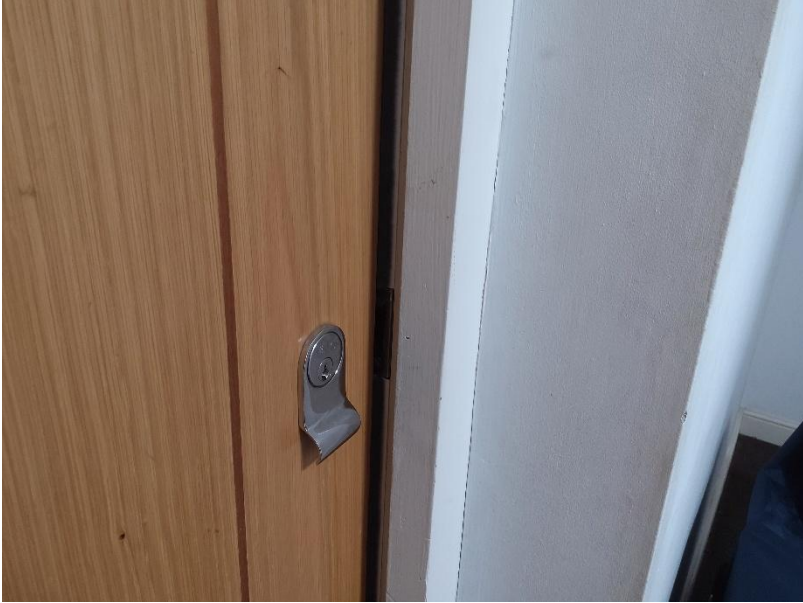
<p style="text-align: center;">03</p>	<p>As per section 33.2 of Fire Safety in Purpose-Built Block of Flats a type 1 fire risk assessment requires us to conduct a fire door survey on a sample of flat front doors. The door to flat 2 was surveyed during this sample in which the following deficiency was found:</p> <ul style="list-style-type: none"> Flat 2's door did not fully self-close <p>It is essential that each flat entrance door is a suitable fire door, providing a minimum of thirty minutes fire resistance, hung on three grade 13 hinges and having a functioning self-closing device fitted that positively closes the door on the latch, together with smoke and intumescent seals. It is recommended therefore that the RP instruct a suitably qualified and competent contractor to conduct a fire door inspection to all flat entrance doors providing advice on suitability as per "Fire Resisting Doors – 62-12 to 62.17" of Fire Safety in Purpose-Built Block of Flats. Any shortcomings identified by this inspection should be addressed as a priority by upgrading or replacing the door.</p> <p>Flat entrance doors, communal area doors, the seals and the self-closing devices should then be subjected to an annual inspection and maintenance schedule.</p>

<p>2</p>	<p>C</p>	<p>Ongoing action required.</p> <p>Inspection carried out in accordance with current legislation</p>
